# STEERING

# RACKS

## Steering

I recently had cause to rebuild a steering rack for my race car and not having covered it before in The Courier I thought a few notes may be of interest.

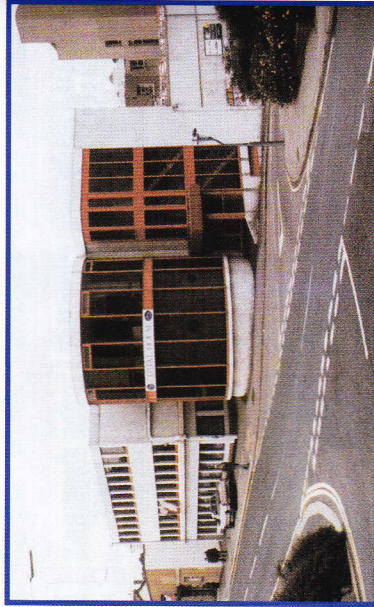
This month's photo was sent in by Mike Hadley from Devon who sent in some nice period information with his IVR for his Valencia Blue Spitfire MKIV. Mike's car is one of the earliest cars on the database, which Mike bought new in December 1970 from S Hicks and Son Ltd., the Standard Triumph dealer in Truro. Mike still has the original bill of sale and the old style logbook as shown here. The other photo shows the old showroom and garages of S Hicks and Son as they are today. Apparently the circular corner elevation was a show area for the latest Triumph model. Mike recalls that his car never made it into the show area as he bought as soon as it arrived! Today the car has 163,000 miles on the clock and is currently undergoing a rebuild to restore it to its former glory.

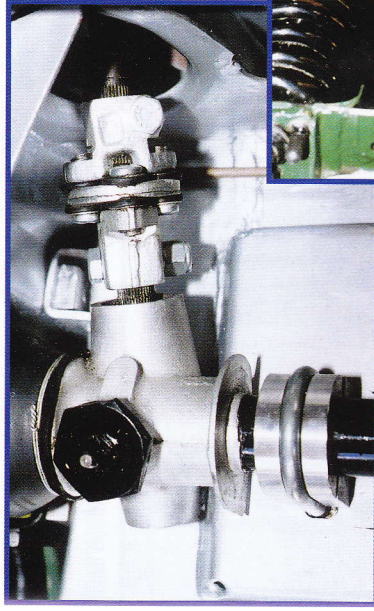
**Fig 1 Solid rack mounts and steering coupling. On early cars, ensure that there is an earth lead between the 2 pinch bolts and another from the grease nipple to the chassis, otherwise the horn won't work**  
a couple other culprits could be to blame. Worn rubber steering rack mounting bushes, especially if softened by years of oil dripping onto them from the timing cover oil seal, can allow the whole rack to move sideways.

Solid Aluminium rack mounts Fig 1 are now very

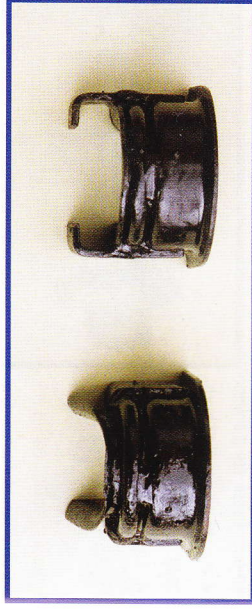
**Fig 2 Two types of rack mounting brackets were used.**  
common and can return a lot of precision to the steering. Alternatively, if you wish to avoid some of the harshness of the aluminium mounts, the more modern

Polybush/Superflex mounts are available which are also impervious to oil contamination. On the subject of mounts, two types of bracket were used Fig 2. Any ideas why? - crash? - better support?

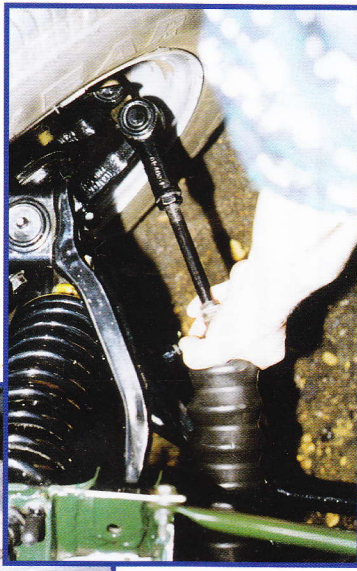
**Fig 3 Check for wear in the bush in the end of the rack tube.**

repair, apply full LH lock. Then grasping the rack at the inner ball joint Fig 3, try and lift the rack up and down. Any movement indicates wear in the bush in the end of the rack tube. It's easier to check for wear here whilst the rack is still on the car.

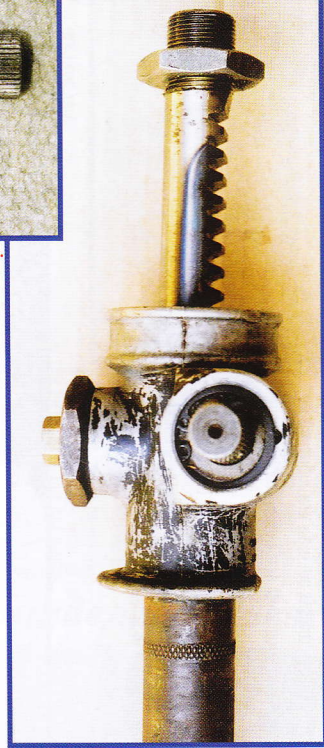
Fig 4. Circlip that holds the pinion in place) The pinion is removed by first removing the circlip Fig 4. Be very careful not to lose the small dowel pin as you withdraw the pinion.

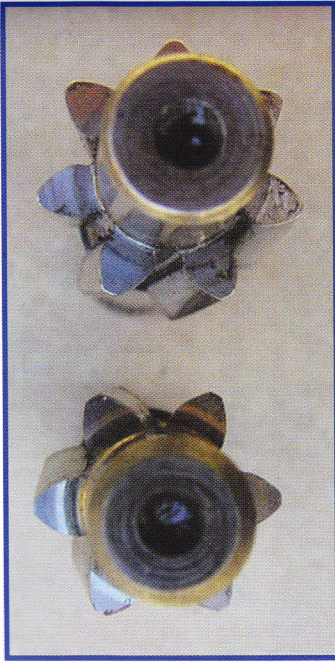
Fig 5. 4-cylinder cars use 6 tooth pinions, 6-cylinder cars have 7 tooth pinions.

Two types of pinion were fitted to 'our' cars. Fig 5. The 6 tooth pinion was fitted to the 4-cylinder cars to give them a 'faster' rack compared to the 7 tooth pinion of the 6-cylinder cars, which due to the extra weight of the 6-cylinder over the front wheels had a

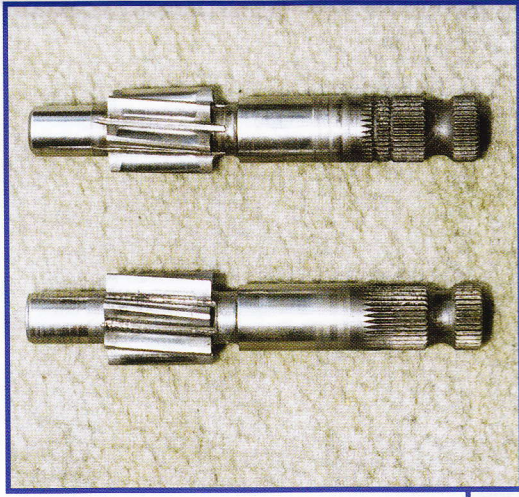
Fig 6. Grooves in the end of the pinion denote its intended use on a 6-cylinder car.

'slower' rack' to reduce steering effort. Hopefully, you have the correct rack fitted - there used to be a fear that you may get the wrong ratio back when exchanging units. A quick way of determining which is which without going through the process of counting the number turns from stop to stop, is to look at the end of the end of the pinion. A 6-cylinder rack will have 2 grooves in it, a 4-cylinder one,

none. Fig 6. All the other parts of the steering rack, including the rack were identical between the cars.

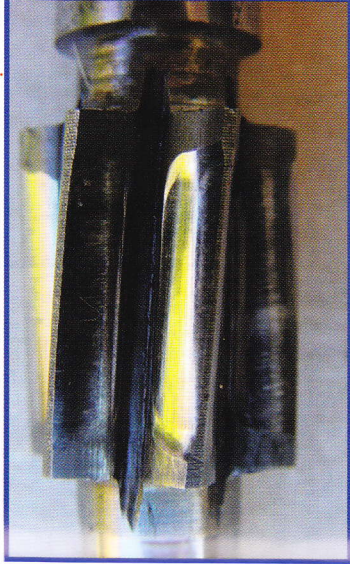
Fig 7. Excessive wear in the pinion.

Check the pinion for wear. It shouldn't look like Fig.7. This was taken from a Vitesse, the much lighter Spitfires are not usually as bad as this.

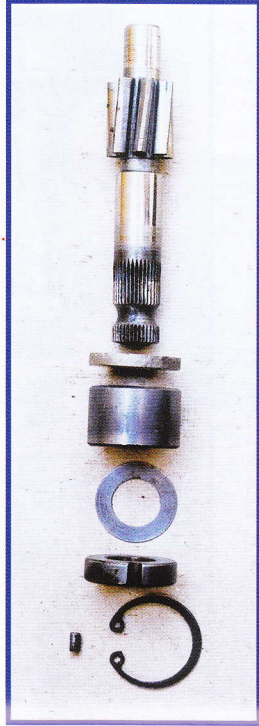
Fig 8. From left to right: circlip, dowel pin, retaining ring, shim, bush, thrust washer, pinion.

Fig 8 shows the correct sequence of components to be assembled. One end of the bush has a small groove in it to allow lubrication of the thrust washer. The retaining ring has an 'O' ring hidden away inside it to prevent the escape of grease every time you grease the rack. Insert shims as necessary, each time

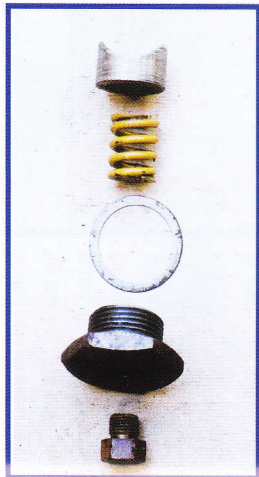
Fig 9 From left to right: grease plug, cap nut, shim, spring, and plunger assembling to the housing, until you can only just detect pinion movement. Any movement is easier to detect if no

This is adjusted by the pinion plunger. A large 1 5/16" spanner is needed to remove the large cap nut. Fig 9 shows the components involved. In this case shims have to be removed to achieve the correct adjustment;

which is specified as a load of 2lbs applied at a radius of 7.9" being able to just rotate the pinion. With the rack in a vice, a pair of medium-sized mole grips gently clamped (not to damage the splines) to the pinion can be used. If the weight of the mole grips when horizontal, can rotate the pinion, then more shims need to be removed. If no more than light finger pressure on the end of the mole grips is required, then the adjustment is about right. Again

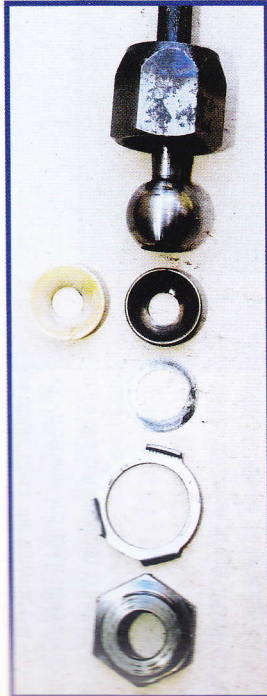
Fig 10(overleaf) shows the parts involved in the adjustment of the inner ball joint end play (NB in this case the sleeve nut was removed from the rack). Two cups are shown, on early racks the cups were steel, later racks using plastic cups. Note also that the spring is not used at this stage. Removing shims will reduce the endplay. Assemble the component, ensuring that the cup nut and sleeve nut are tight together and then with the cup nut held in a vice try and articulate the end of the track rod. The official figure is a load of 1lb should move the end of the track rod. In practice it should be just a little stiff to move. However, make sure that the

**Fig 10** From left to right: sleeve nut, tab washer, shim, cup (steel or plastic), track rod, cup nut

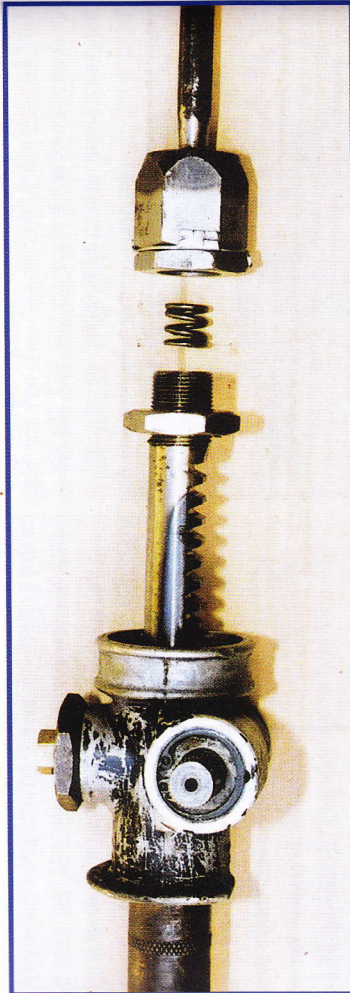
**Fig 11** (photo 5) Inner ball joint assembly ready for fitment to rack. NB spring.

Once happy with the adjustment, assemble the components back onto the end of the rack as in Fig 11. Don't forget to refit the spring at this stage. As the ball joint assembly is tightened onto the end of the rack, the spring will make the track rod become a lot stiffer.

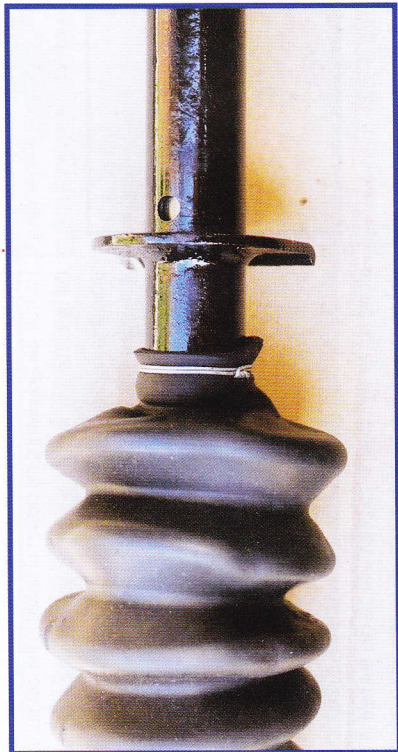
**Fig 12** Locating hole for nylon button  
With a little use and as more grease is worked into the ball and

**Fig 13.** An irritating rattle which sometimes occurred in the rack-and-pinion steering was cured by the very simple expedient of drilling the rack tube and inserting a Nylon Button at the mounting point where resiliency of the rubber provided sufficient pressure to take up any play in the rack.

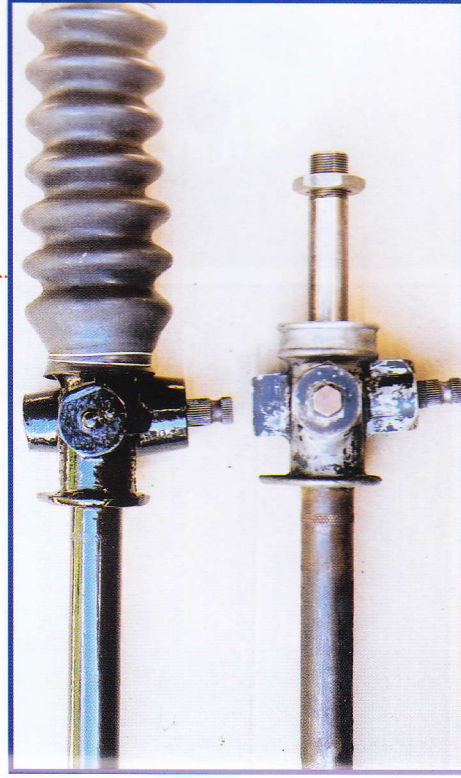
**Fig 15** shows 2 types of pinion housing that were used.

Any ideas why - different suppliers?
